Single event investigation

Devastation in Karen State

Airstrikes on a Monastery and mining facilities, Kyainseikgyi Township

Report by MYANMAR WITNESS FELLOWSHIP PROGRAMME, 19 May 2023

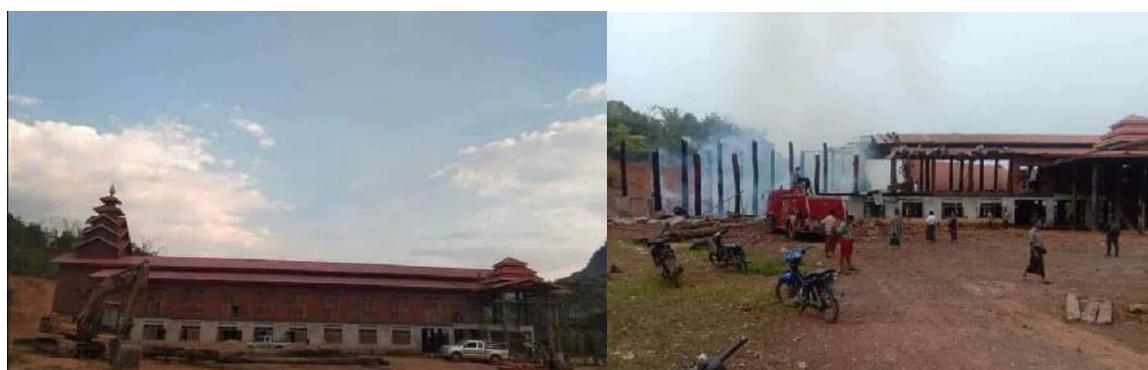
Figure 3: (Left) The Dhamma Rakkhita Monastery before the attack (Source: [Mon News](#)). (Right) Imagery of damage after the airstrike (Source: [Khit Thit Media](#)).

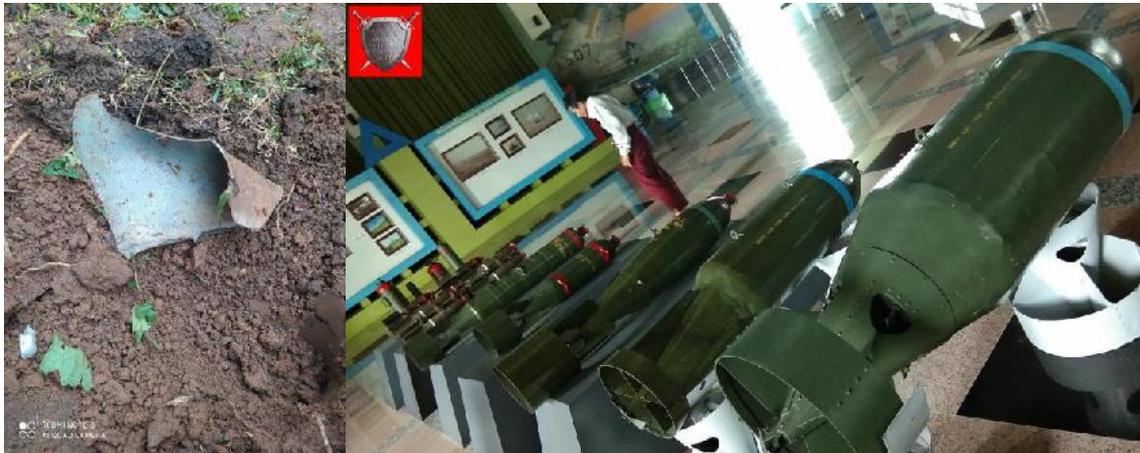
According to the town's inhabitants, as reported by [KIC](#), weapon fragments were found inside the Dhamma Rakkhita Monastery after the attack. The exact type of munition alleged to have been used is not confirmed; however, analysis conducted by Myanmar Witness shows that the fragment is likely from 250-pound or 500-pound bombs. Myanmar Witness has identified reports that these types of bombs have been frequently deployed by the MAF in Karen state.

Figure 6: (Left) Suspected bomb fragments found near the monastery after the airstrike (Source - [KIC](#)). (Right) Bombs commonly used by the SAC in air strikes which are suspected to be the bomb used (Source - [Myanmar Military Online Study](#)).

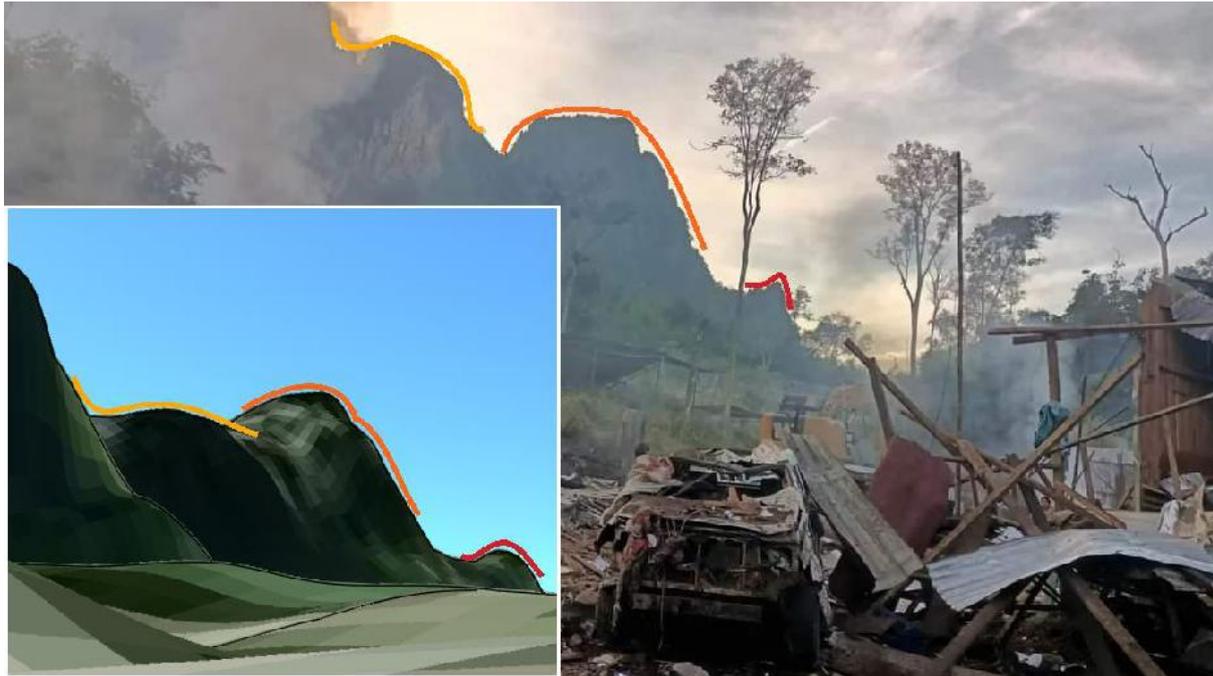
Figure 7: The scene after the airstrike against block 6 of the Thabyu Mine (သံဂျိဇ်း) reportedly on the morning of 16 November 2022. Location of the damages is verified with [Peakvisor](#) [15.619399, 98.406799] (Source: [Khit Thit Media](#)).

Images released online by news source [Khit Thit Media](#), allegedly following the airstrike on 16 November 2022, show extensive damage to the mine site. However, Myanmar Witness has been unable to geolocate or chronolocate these images with confidence.

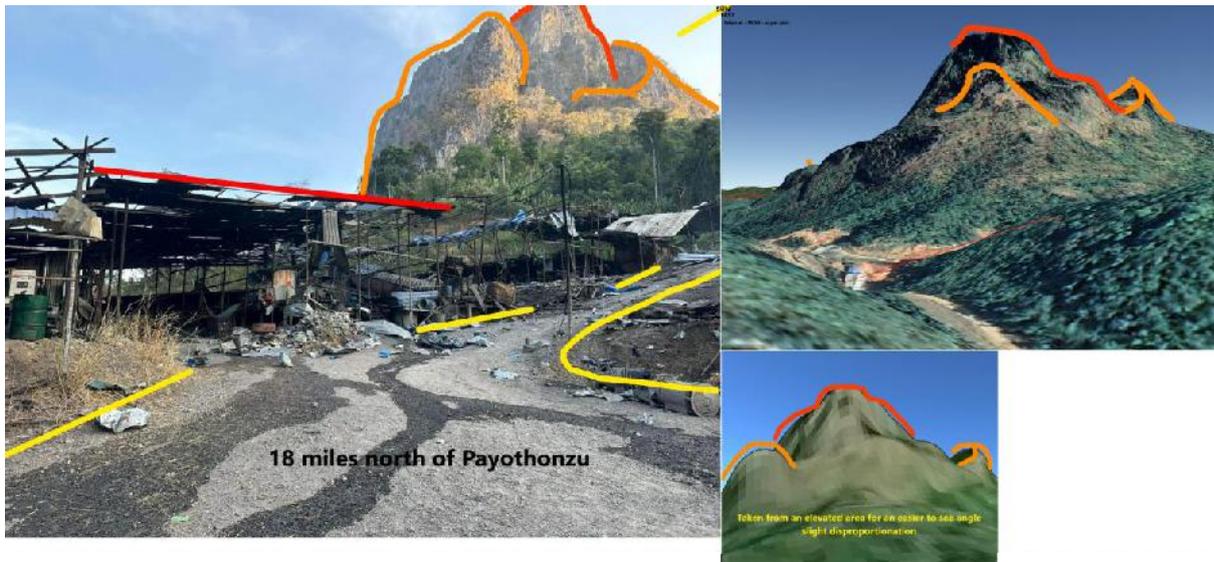
Images released following the alleged 25 January airstrike show damage to another section of the mine site. The location of the damaged buildings in ‘block 5’ was confirmed using [Peakvisor](#), which was used to match the surrounding mountains. However, Myanmar Witness was unable to chronolocate the images with confidence.

Figure 8: The location of block 5, reportedly attacked on 25 January 2023, can be confirmed by comparing it with the mountainous terrain seen on Google Earth and Peakvisor [15.606206, 98.410007]. (Source redacted due to privacy/safety concerns).

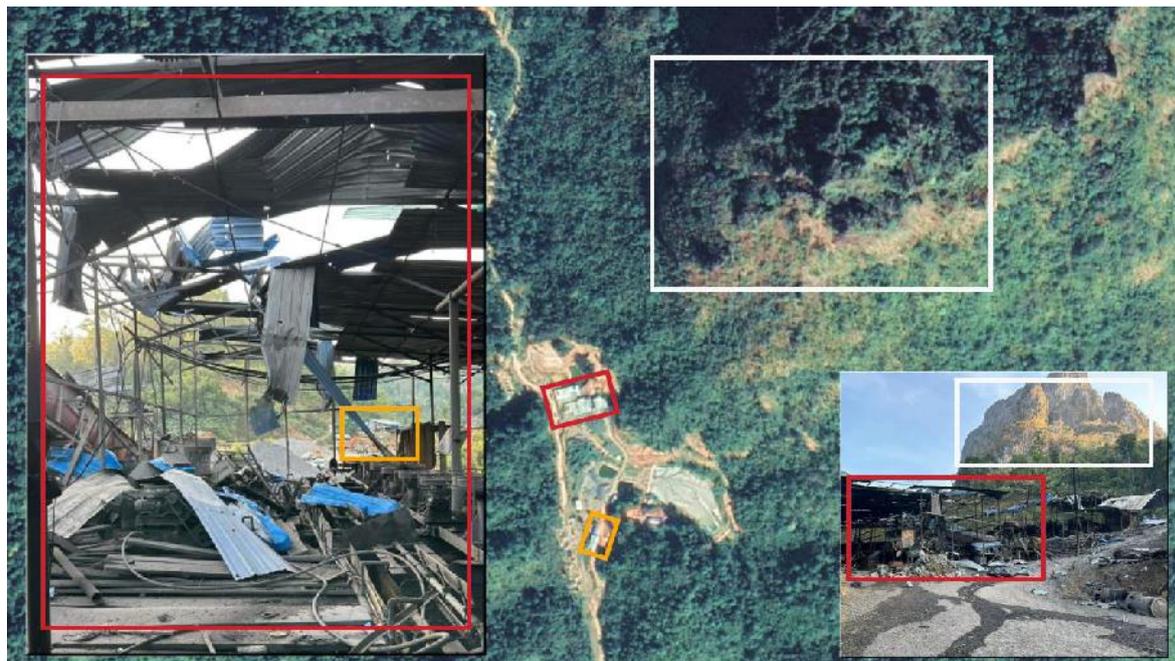
The damaged buildings were also checked and verified against [Google Earth](#) satellite imagery.

Figure 9: Confirmation of the geolocation of the damages to block 5 of Thabyu Mine [15.606206, 98.410007].
 (Source redacted due to privacy/safety concerns)
